Re: **Approved Jurisdictional Determinations, U. S. Army Corp of Engineers Permit SPL-2008-00816**

**RE: Rosemont Mine Approved Jurisdictional Determination, U. S. Army Corp of Engineers Permit SPL-2008-00816**

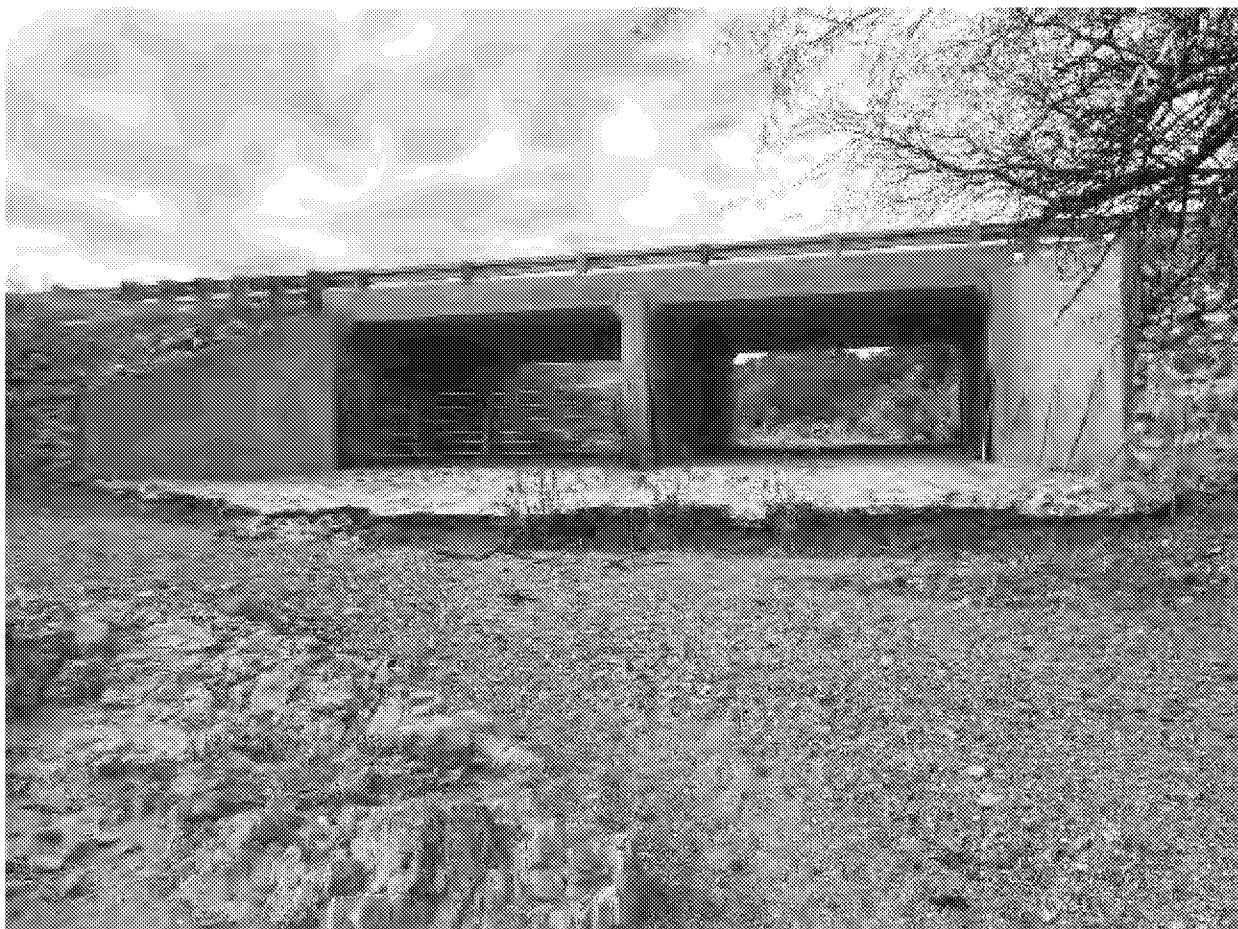
**Figure 1. Observation Point 1-1 Photograph by WestLand, looking upstream across concrete apron from a position downstream of the USGS gage. December 22, 2020.**

The photographs included here and all the other photographs in the WestLand memorandum directly contradict the Corps’ highly dubious assertion that water retained at the bridge is responsible for the dried algae observed by WestLand Resources staff along the wall of the culvert. That the Corps could come to this conclusion in direct contradiction of all available evidence points to apparent bias and calls for a reconsideration of their determination.

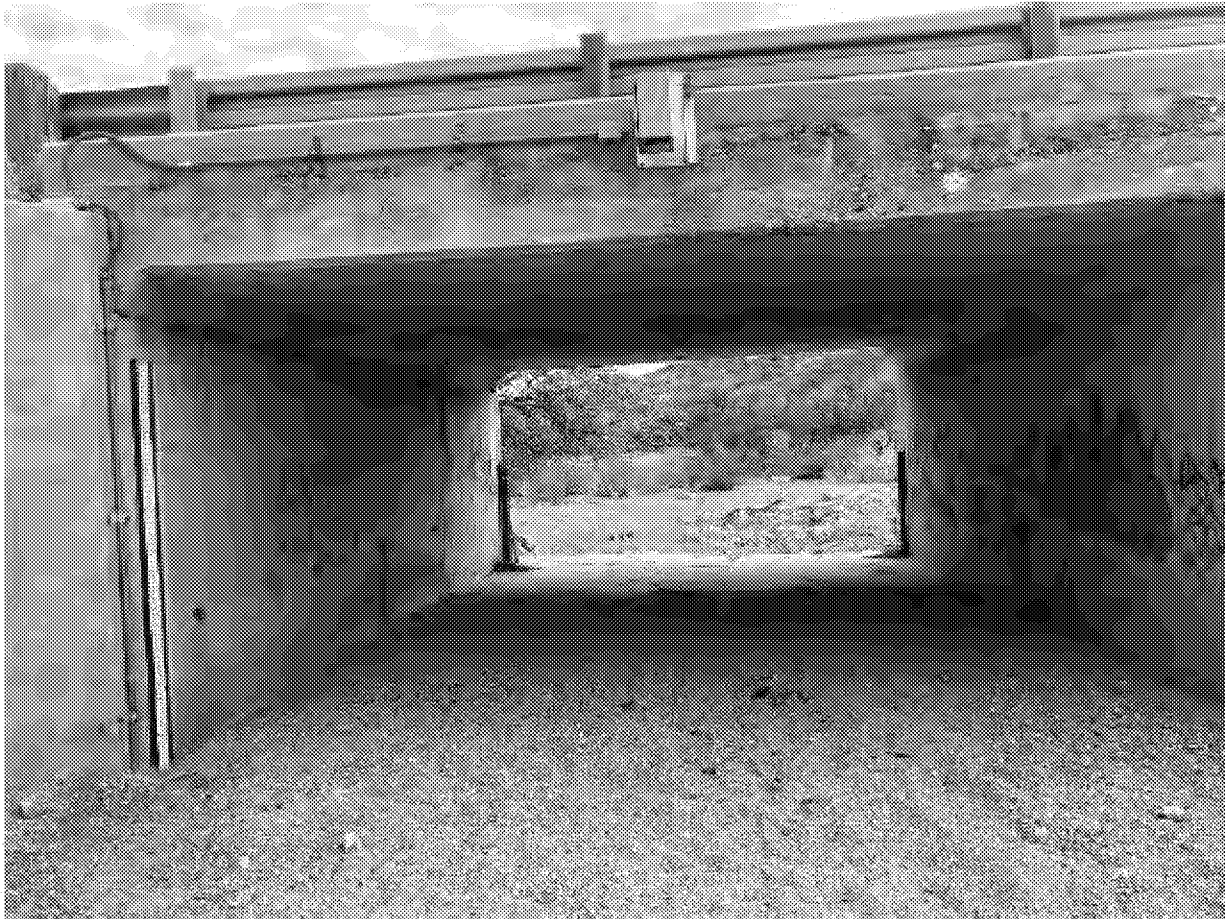
Figure 2. Observation Point 2-2. Looking downstream across northern box culvert. No scour holes or evidence of retained flow in the culvert to account for the dried algae observed by WestLand on northern wall downstream of the white staff gage. Note coarseness of the sediment being transported by flows. December 22, 2020, photo by WestLand.

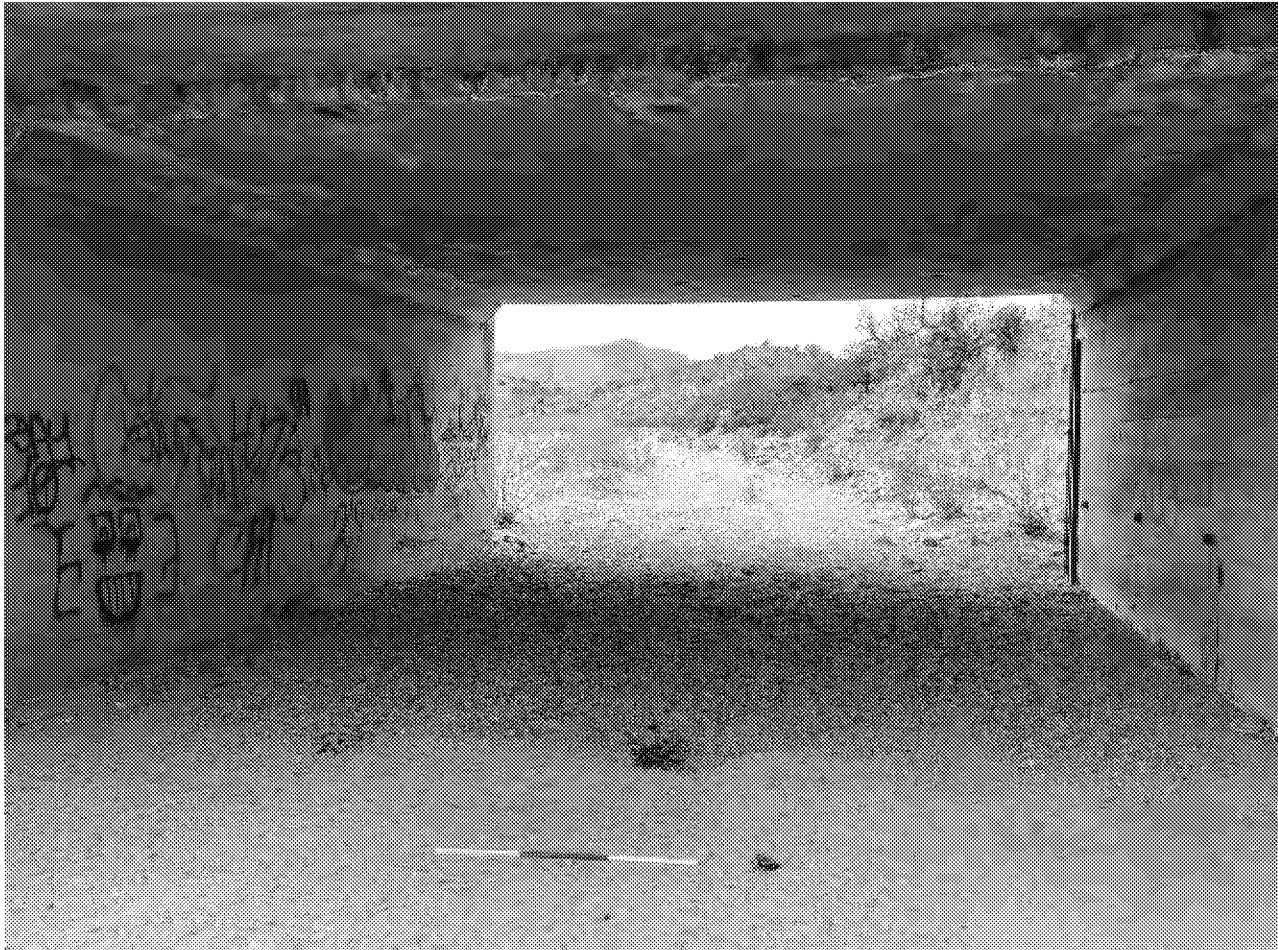
**Figure 3. Observation Point 2-1. Northern box culvert looking upstream. Note lack of obstructed flow, scour holes or other evidence of retained flow upstream. WestLand report notes dried algae on northern wall. December 22, 2020, WestLand photo.**

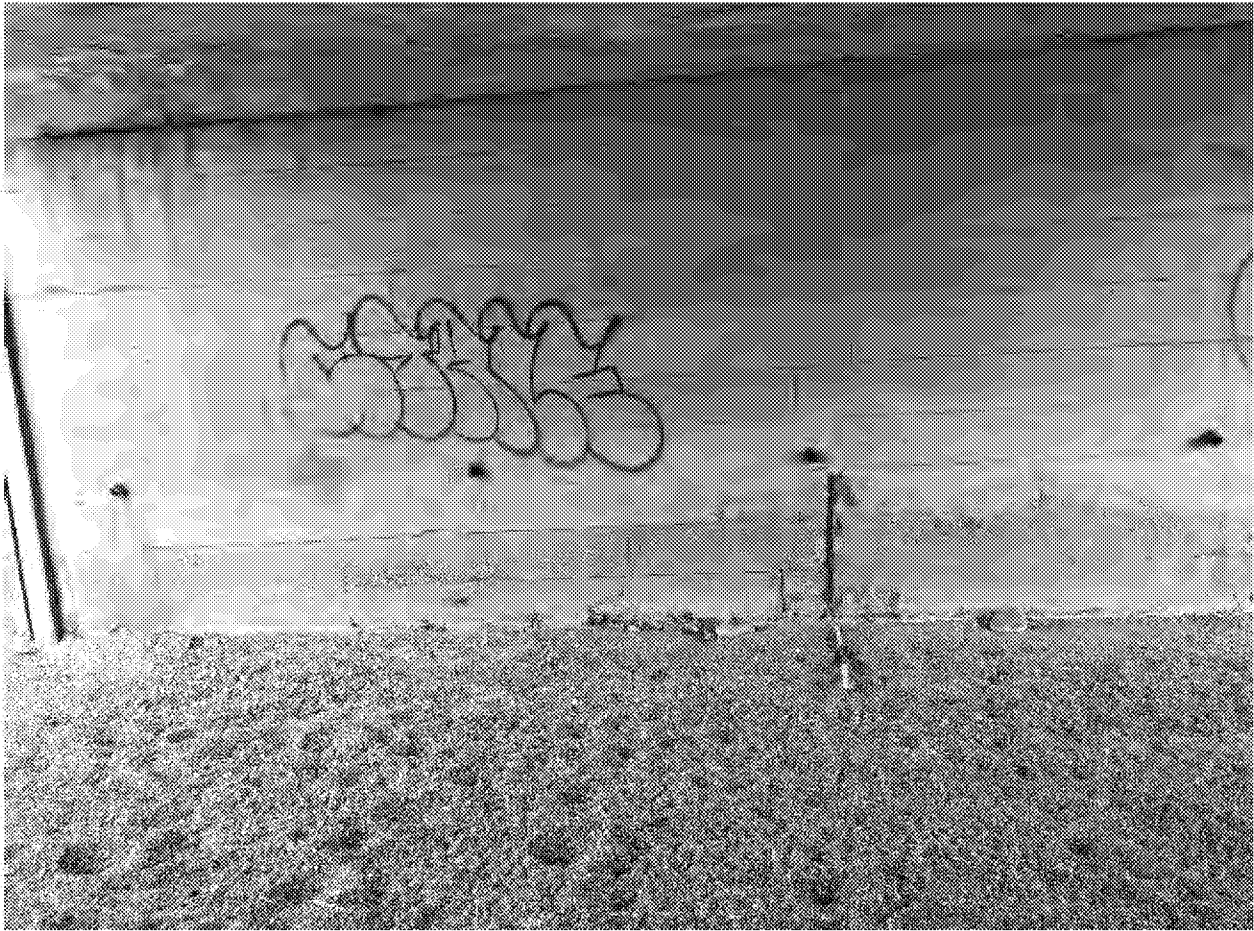
**Figure 4. Observation Point 2-2. Showing dried algae noted by WestLand along base of the northern wall of the box culvert. Note presence of gravel, which is inconsistent with the assumption that retained flow is responsible for growth of algae or intermittent flow. December 22, 2020, WestLand.**

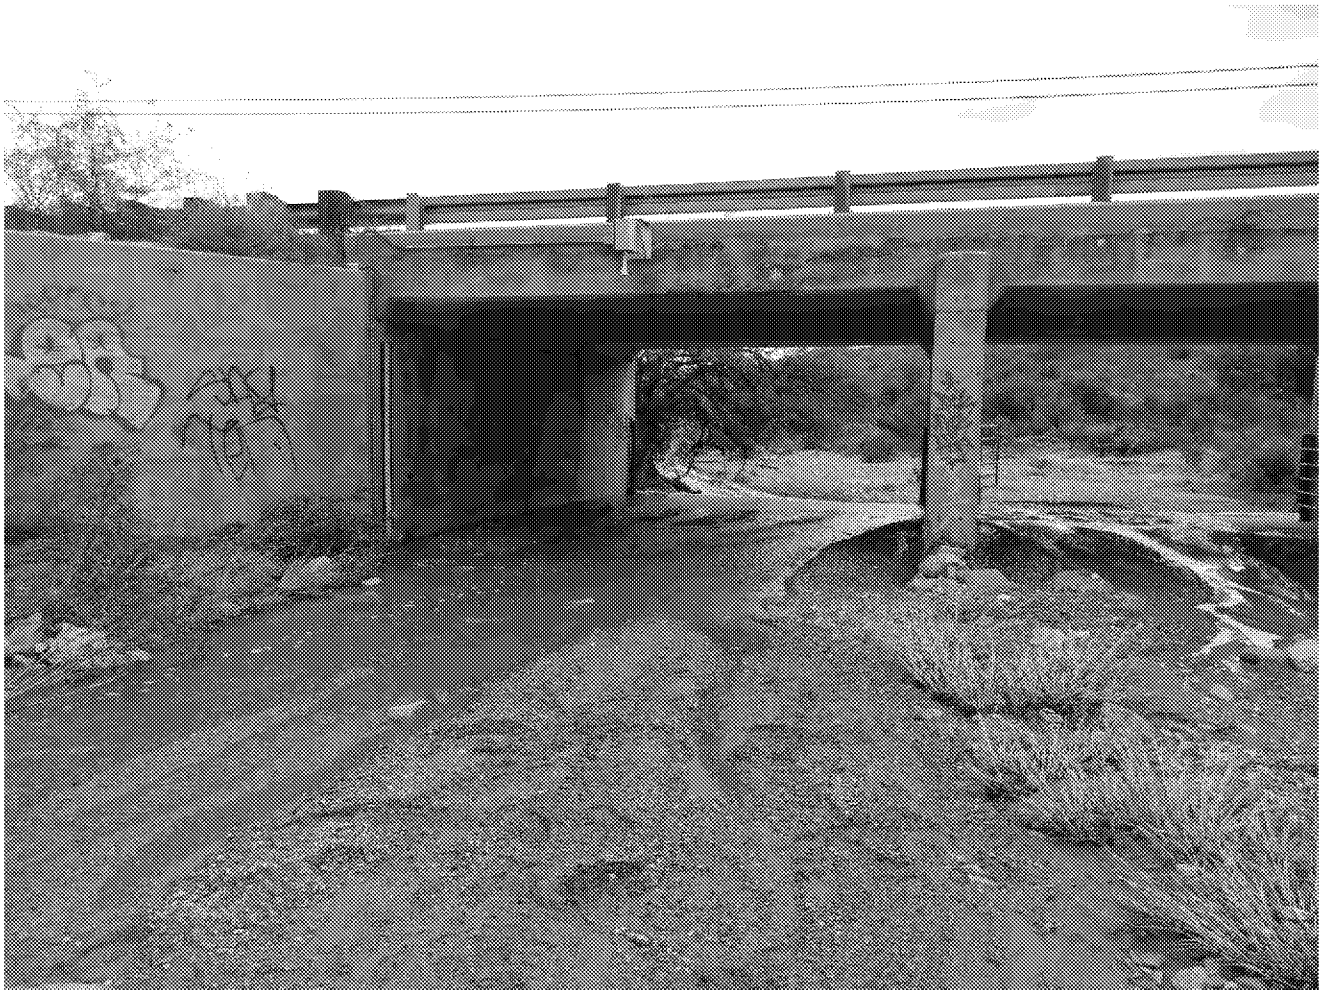
**Figure 5. Barrel Canyon box culvert looking downstream, note positive flow and lack of evidence for retained or impounded flow. USGS gage at left, photograph by USGS, September 4, 2015, the same date that rainfall occurred at this site.**

The algae observed by WestLand is evidence of intermittent flow; similar evidence is readily available but was ignored by the Corps so we provide it here. For example, Figure 5 shows unobstructed flow exists at the gage location on Barrel Canyon during U. S. Geological Survey's field visit of September 4, 2015.

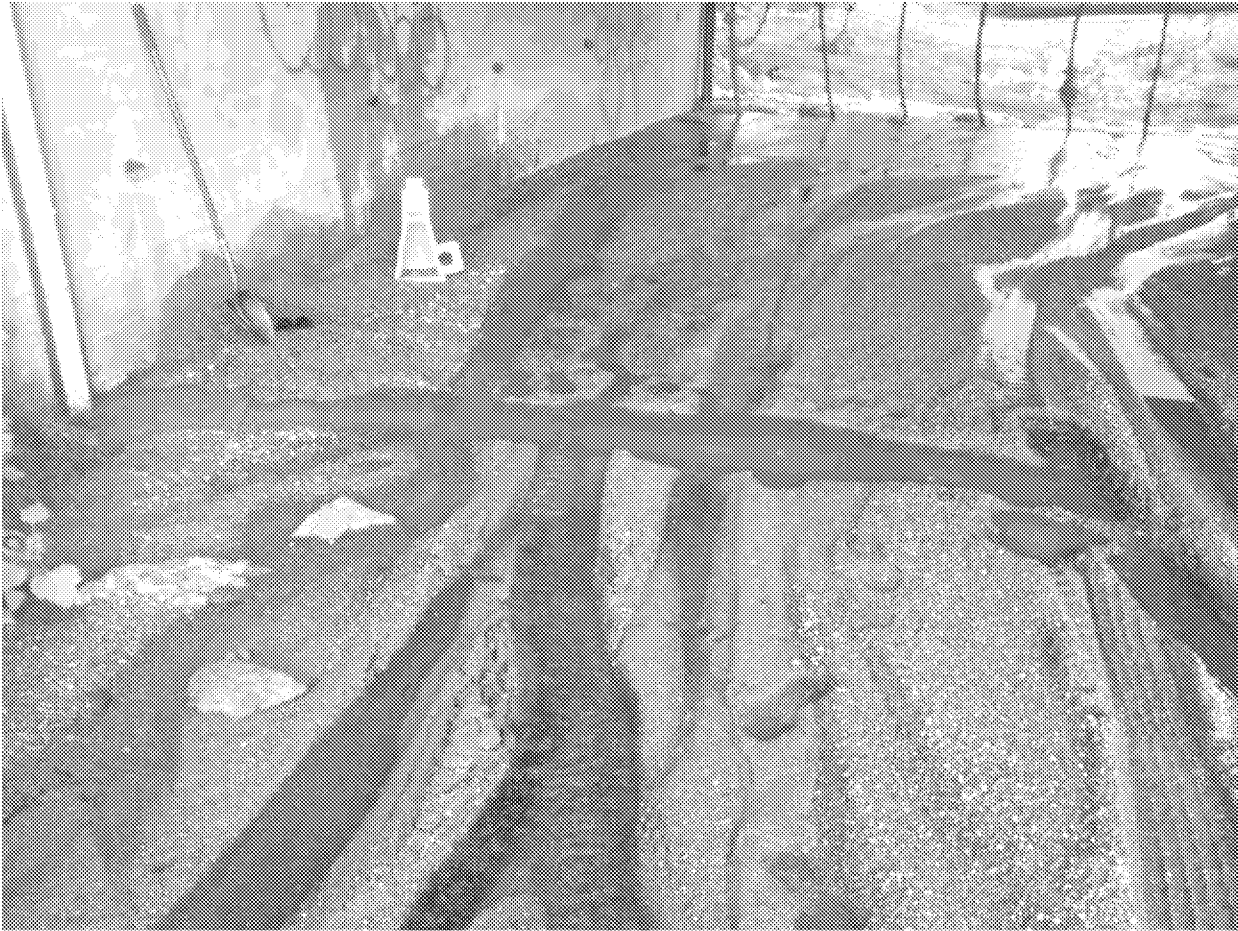
Figure 6 shows unobstructed flow at the USGS gage site on Barrel Canyon, five days after the last rain measured. Note evidence of algae in bed of stream just upstream of the gage and water clarity. Note gravel. Photograph was taken by USGS staff during a field visit on October 14, 2015.

Figures 6-9 provide visual evidence of persistent, intermittent flows documented in the gage data that the Corps failed to review. There is no evidence that the agency examined any of the USGS' site photographs for corroborating evidence at the Barrel Canyon gage, let alone reviewing contemporaneous USGS field measurements of base flows for evidence of intermittency. Examination of USGS hydrographs of flow events from the gage can also be instructive and are readily available; these can be generated online. For example, Figure 9 shows small flows persisted for several weeks in February and March of 2019.

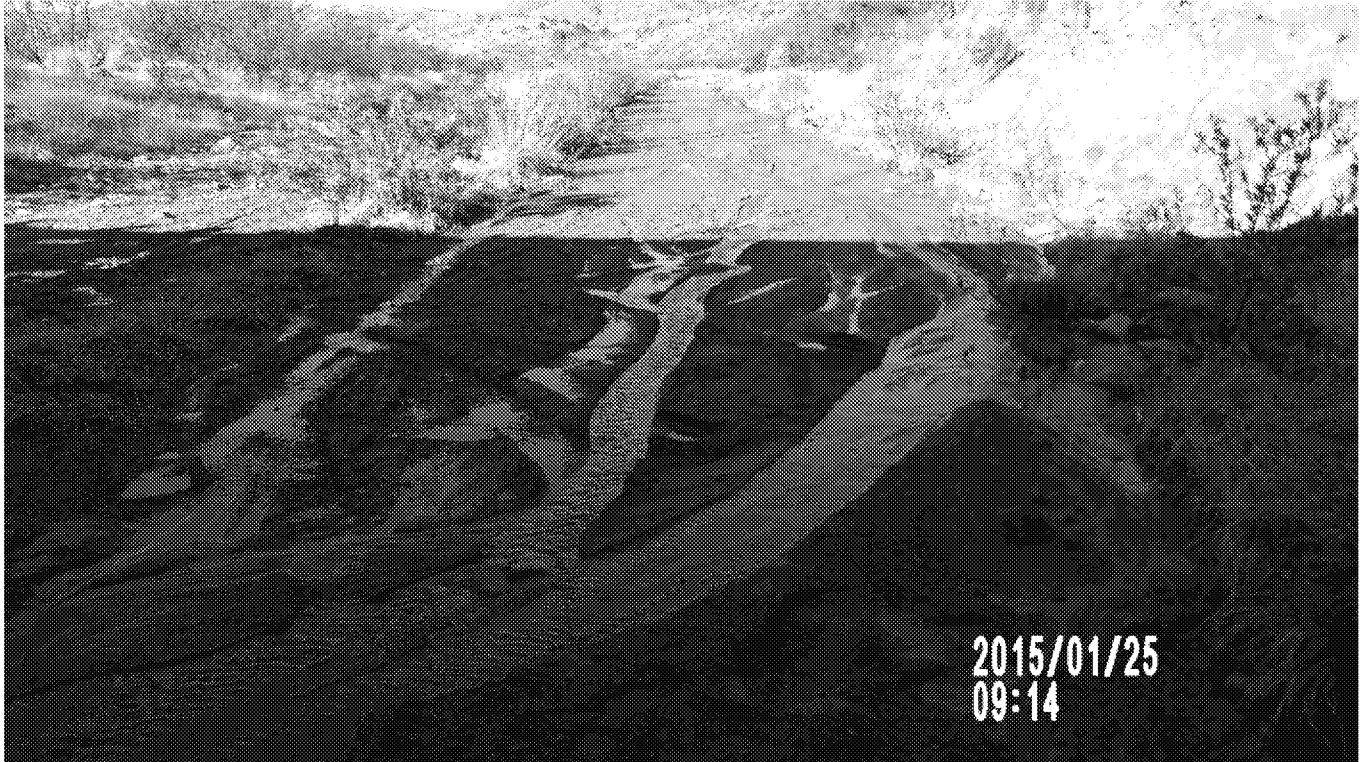
**Figure 7 shows wetted stream bed with positive drainage and no evidence of retained flow upstream of the stream gage along Barrel Canyon in 2016. The camera date/time was mis-set to read 2015 (E. McGuire, personal communication in Pima County 2017).**

Figure 7 is a photograph by USGS staff during a field visit on January 25, 2016, 14 days after the last significant rainfall measured at the site. (0.01 inch fell January 16, 2016.) This intermittent base flow is the cause of prolonged surface water observations at the gage, not pooled water.

The Corps response is to call observations of algae either "anecdotal" or the result of "pooled water" at the gage, whereas USGS staff notes the algae grows in the wetted channel. Figure 7 clearly shows upstream base flows observed contemporaneously with the algae and water observed in Figure 8. Algae grows in sunlight and in January, the culvert is dark most of the time. Any algae here on this date is not the result of a stagnant and isolated pond.

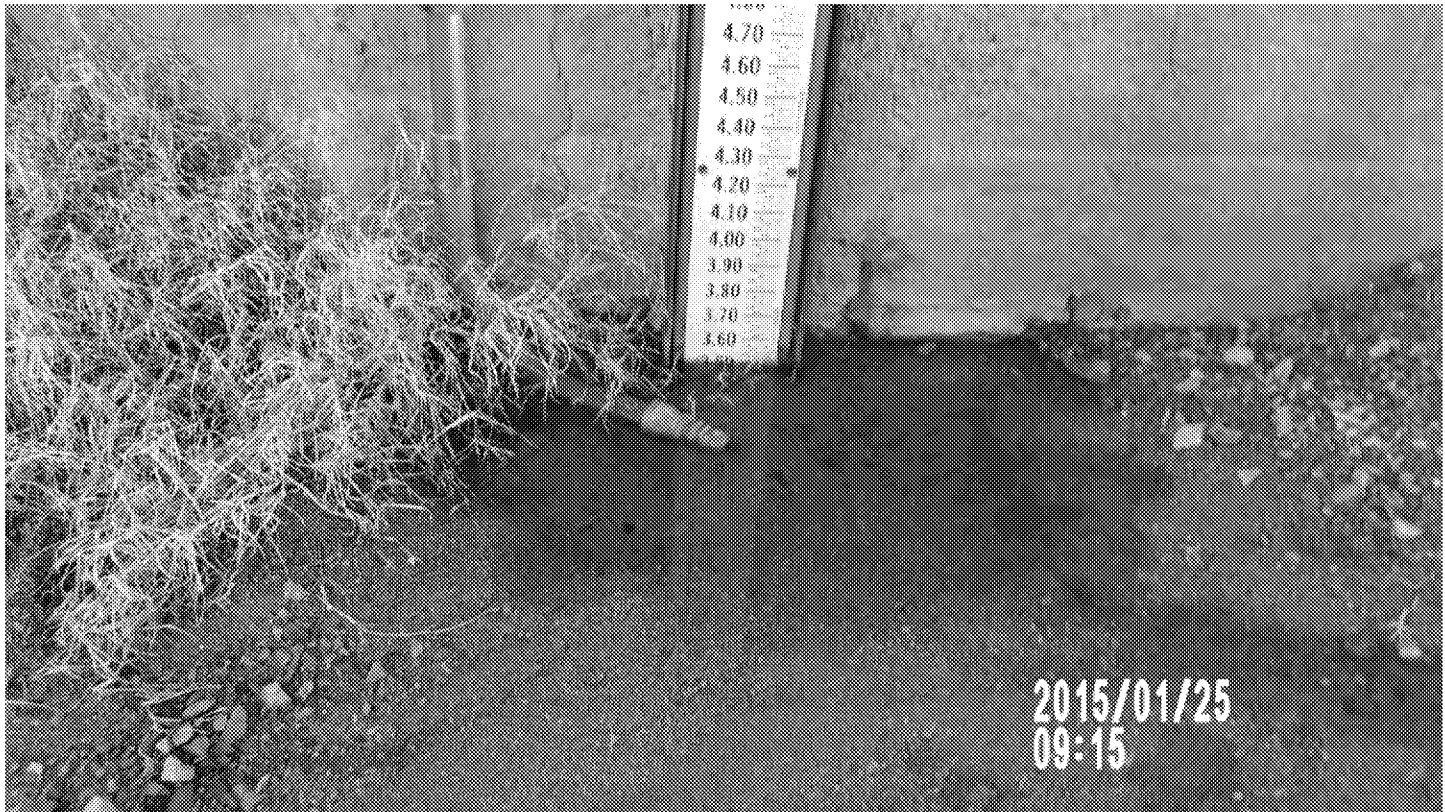
**Figure 8 shows algae at the USGS stream gage. Note clarity of base flow and wetted sediment.**

Mr. Emmett McGuire also said of Figure 8: "The photo does show algae in a pool of water surrounding the pressure transducer tip. I have noticed *algae growing in the wetted channel* during other visits as well." [Emphasis added.]

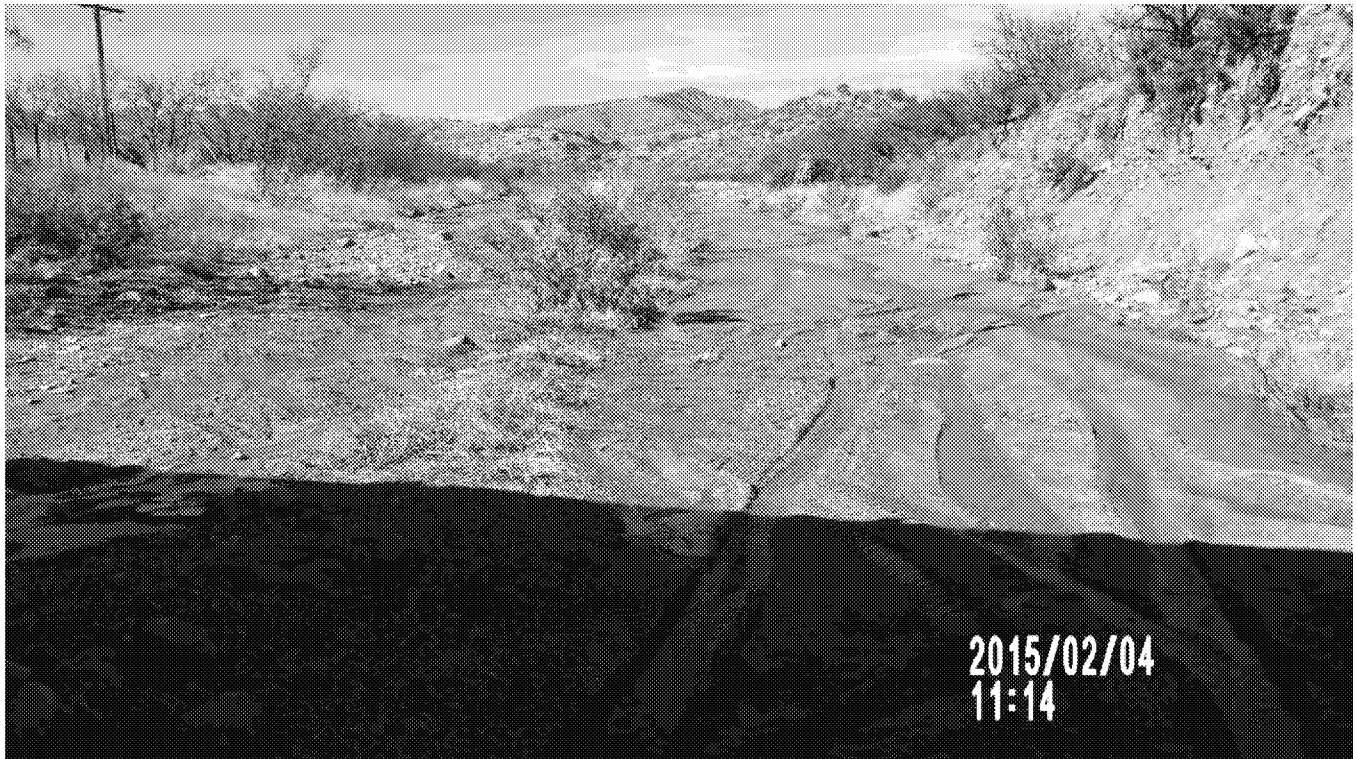
Figure 9 shows streambed wetted by persistent flow upstream of the stream gage along Barrel Canyon during a field visit on February 4, 2015, two days after last rainfall. No evidence of retained floodwater or disruption by the bridge. Photograph by USGS.

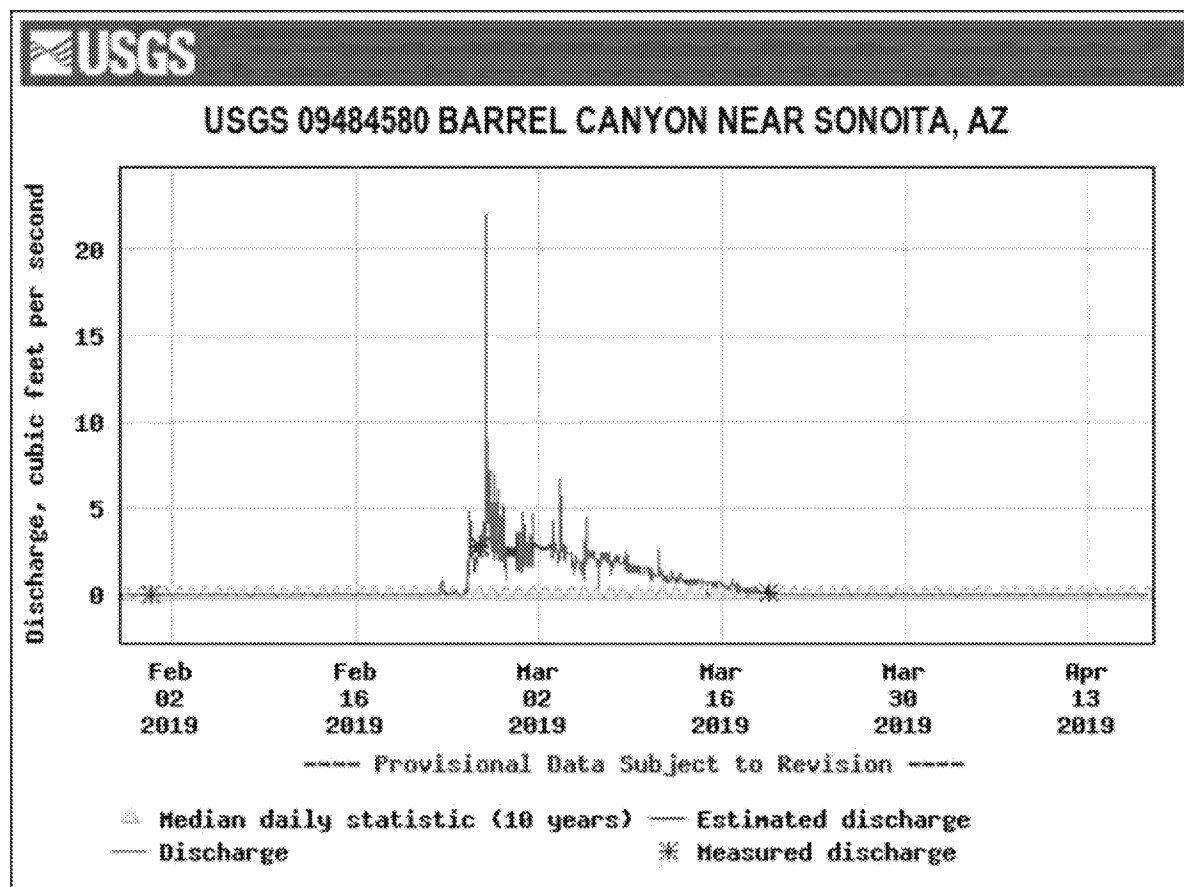
Figure 10. Persistent flows at the USGS gage at SR83 in February-March 2019. Red dates are field measurements of flow by USGS, to verify the gage recordings.

Sharp, short duration peak of over 20 cubic feet per second (cfs) is characteristic of direct runoff. This is superimposed on a long “tail” of base flows ranging from three or fewer cubic feet per second lasting several weeks. These lower, persistent discharges are characteristic of intermittent flows. Barrel Canyon is an undammed stream, and the Corps has provided no alternative evidence for upstream regulation or impoundment of flow that could cause these effects.

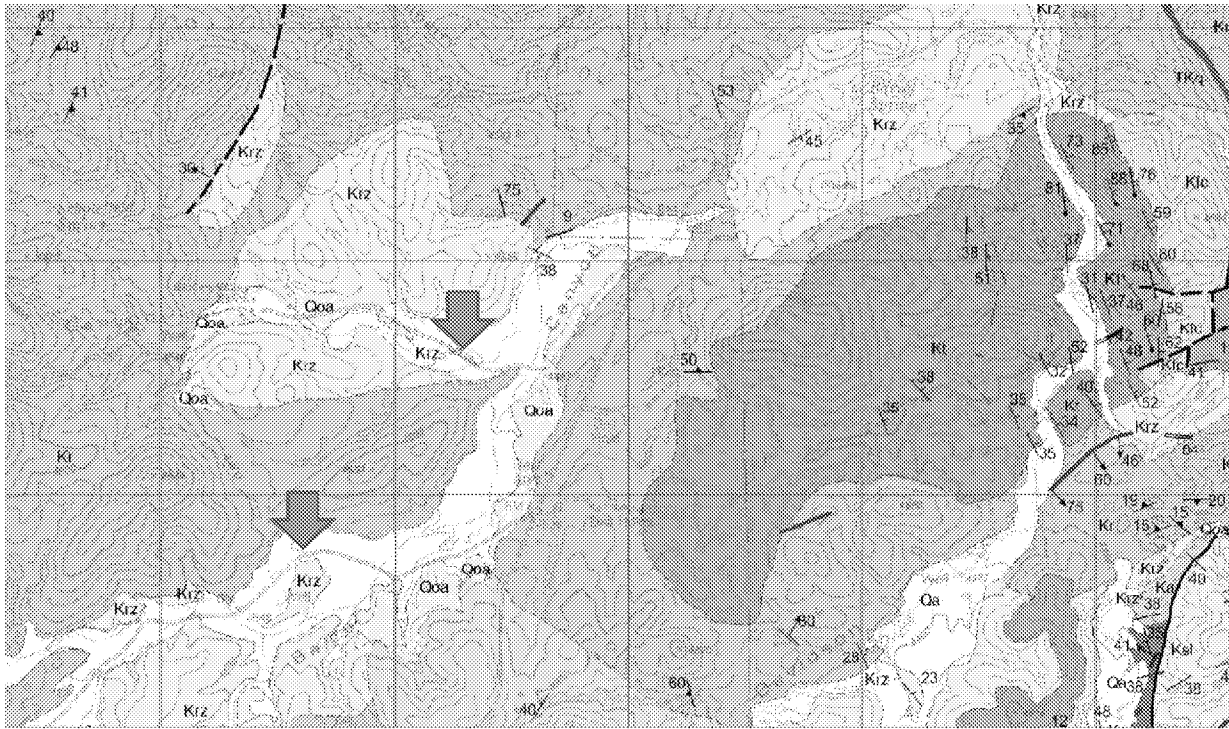
**Figure 11. Geologic map of the northern part of the Empire Ranch 7 ½ minute quadrangle, Pima County, Arizona, by C. A. Ferguson, 2009. Arizona Geological Survey Open-Filed Report 09-05, version 1.0. Blue arrows added to emphasize bedrock outcrops surrounded by sediment.**

This geologic map supports an interpretation of what hydrologists sometimes call a “shoestring aquifer” of Quaternary alluvium overlying bedrock of Cretaceous (K) age. Shoestring aquifers are narrow “strings” of loose sediment surrounded by bedrock, usually corresponding with the boundaries of the geologic floodplain. Because of their small size, they can quickly fill and drain. In Figure 11, sediment, as known as alluvium, is shown in yellow. The other colors are bedrock. Note the occurrence of small green Cretaceous (Krz) outcrops surrounded by the yellow alluvium in Scholefield and Barrel Canyons upstream of the SR83 highway crossing. The arrows show bedrock “peeking” through thin sediment. Even more important, the geologic map shows that yellow alluvium is absent just downstream of the highway; here the stream flows over a mass of green and pink color representing bedrock. This is the end of the “shoestring”.

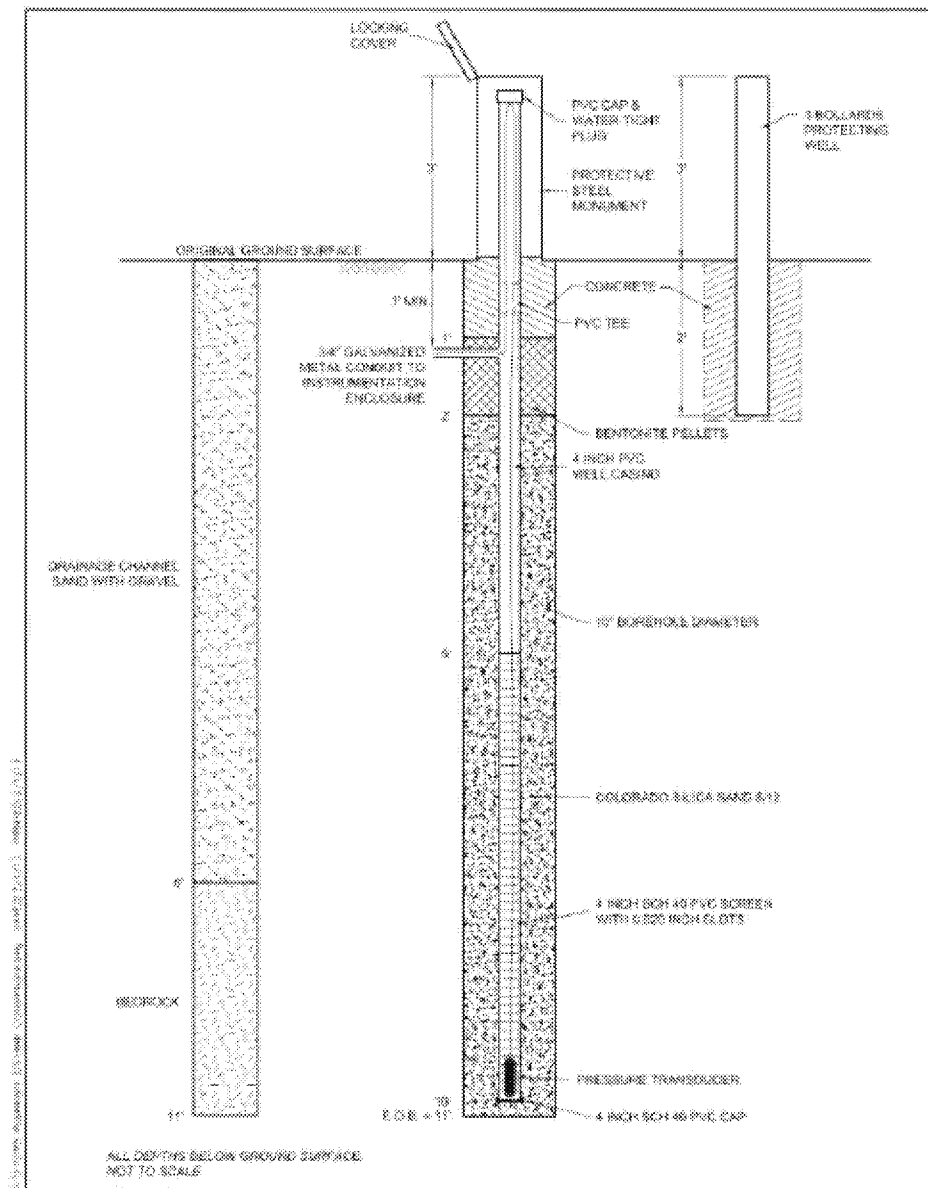
Figure 4. Barrel Canyon well BC-2A-GW lithology and well completion.

In fact, bedrock lies only eight feet below land surface at the Hudbay monitor well located approximately 0.3 miles upstream of the USGS gage on Barrel Canyon (Figure 12), and bedrock outcrops just downstream of the USGS gage (Figure 13). Intermittent flow likely occurs when the shallow alluvial cover is sufficiently saturated upstream of the big green mass of bedrock, much like water spilling over the lip of a cup.

This is contradicted by available evidence, specifically a January 16, 2015 memorandum prepared by Hudbay (2015e) that shows the depth to water in the alluvial well at BC2 on the dates measured in 2014 varied from 0 to 2.55 ft. According to a 2014 analysis of Barrel Canyon and Davidson Canyon Instrumentation data, the groundwater level in December 2013 was around 2 feet (WET 2014). The construction log for the alluvial well is shown in Figure 11.

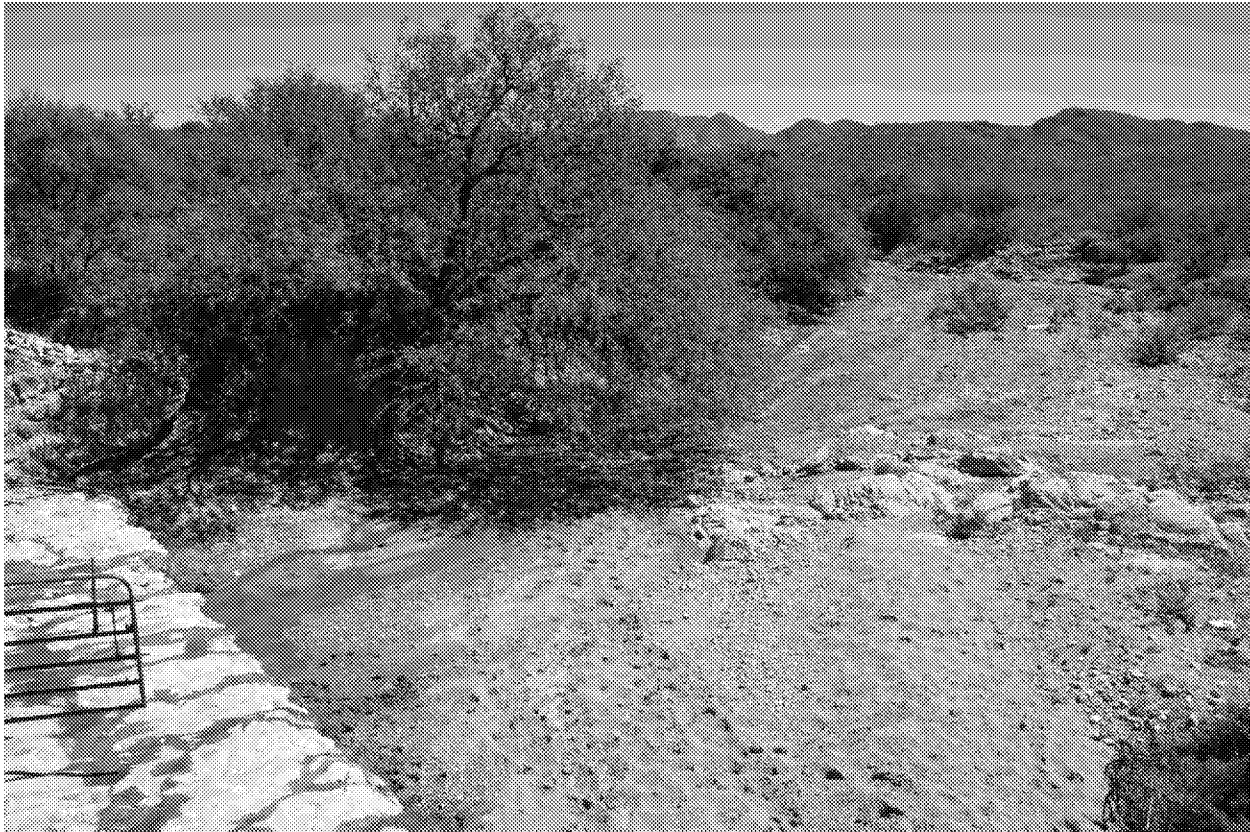
**Figure 13. View of two bedrock outcrops looking downstream from the SR83 box culverts. August 16, 2017. Photograph by Julia Fonseca, Pima County.**

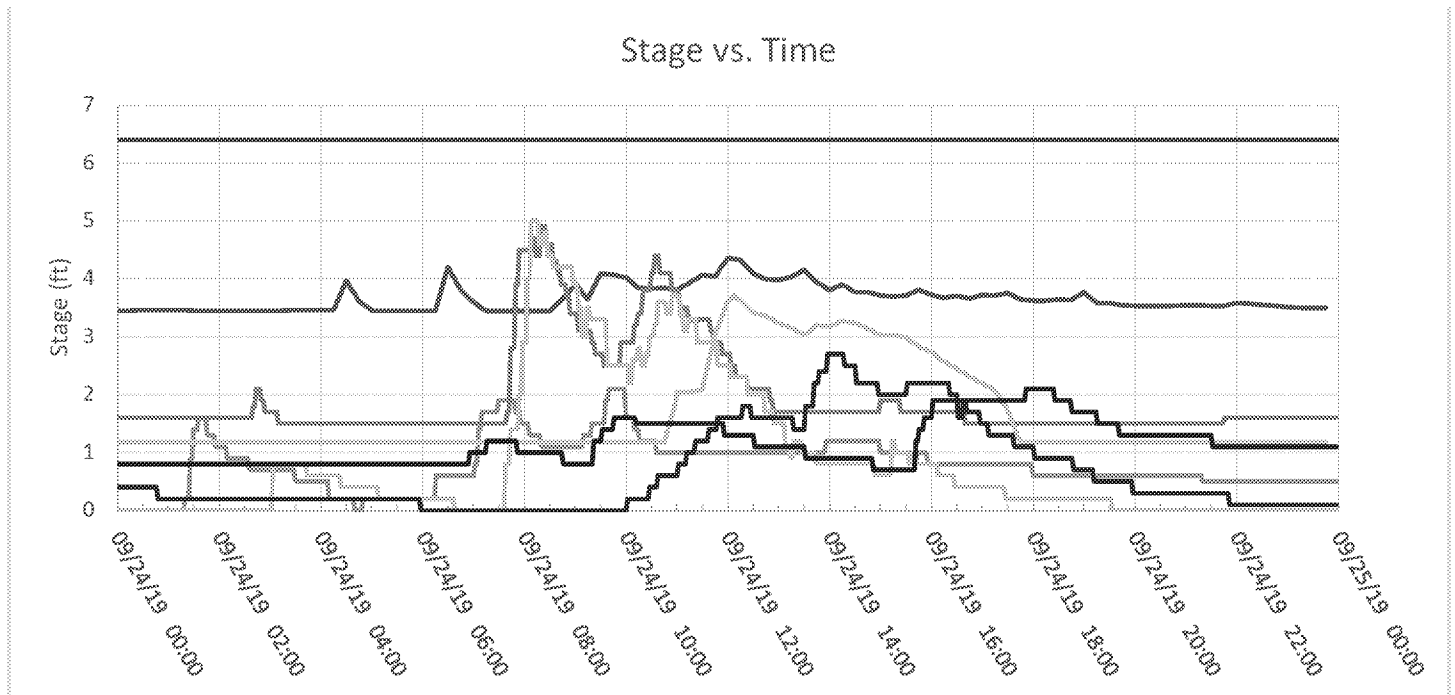
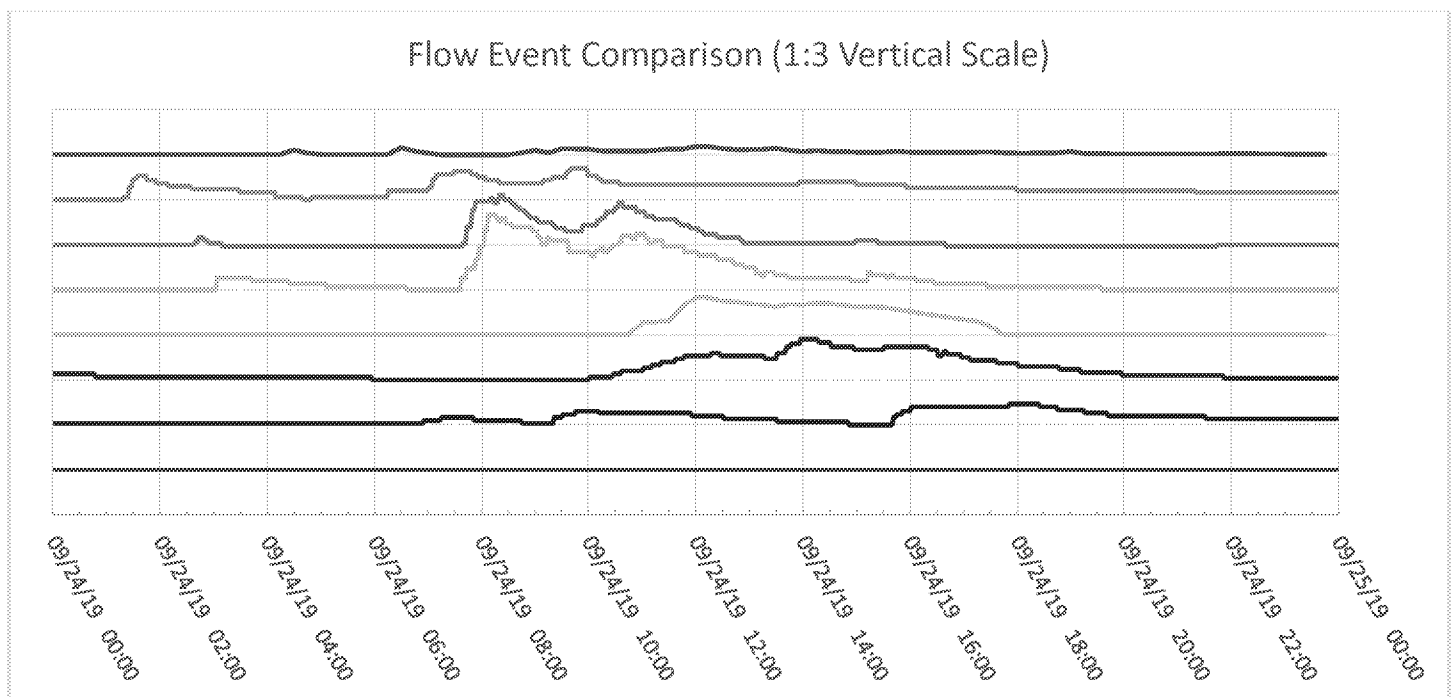
24 September 2019

24-hour Qualitative Precipitation Estimate: Recorded at 11:55 PM 9/24/2019

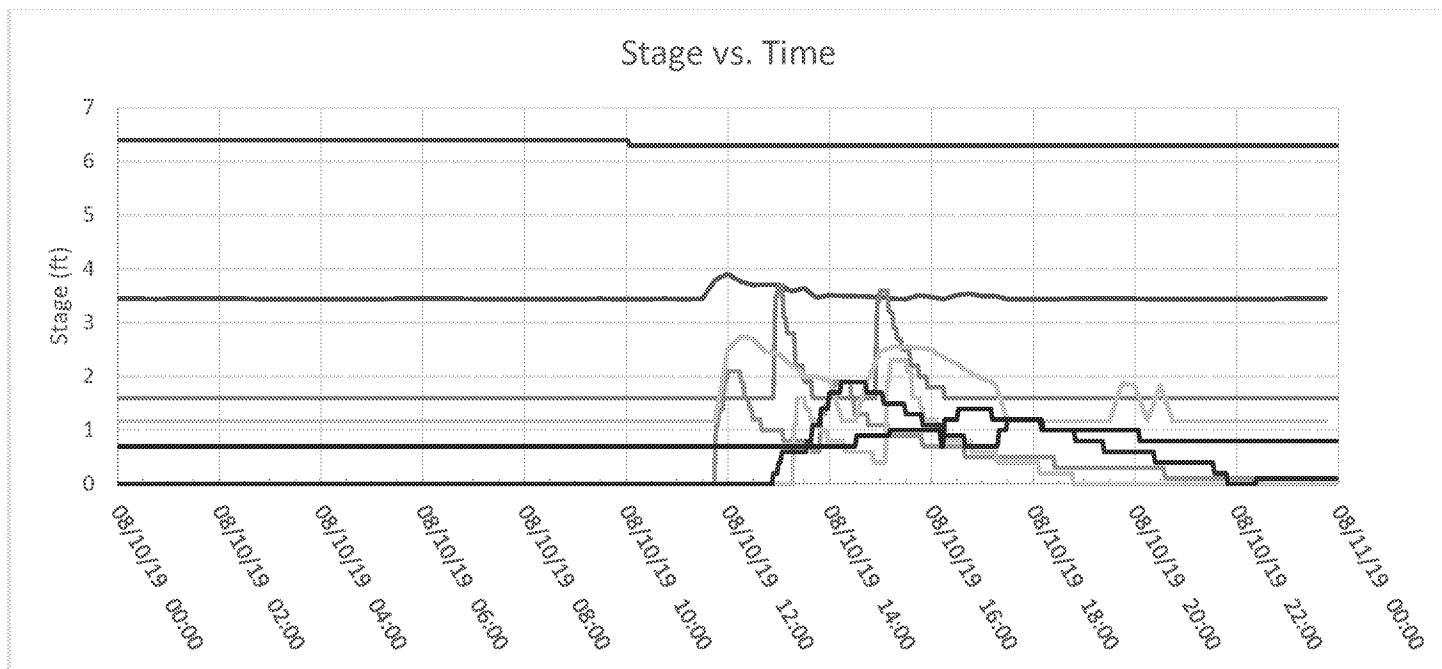
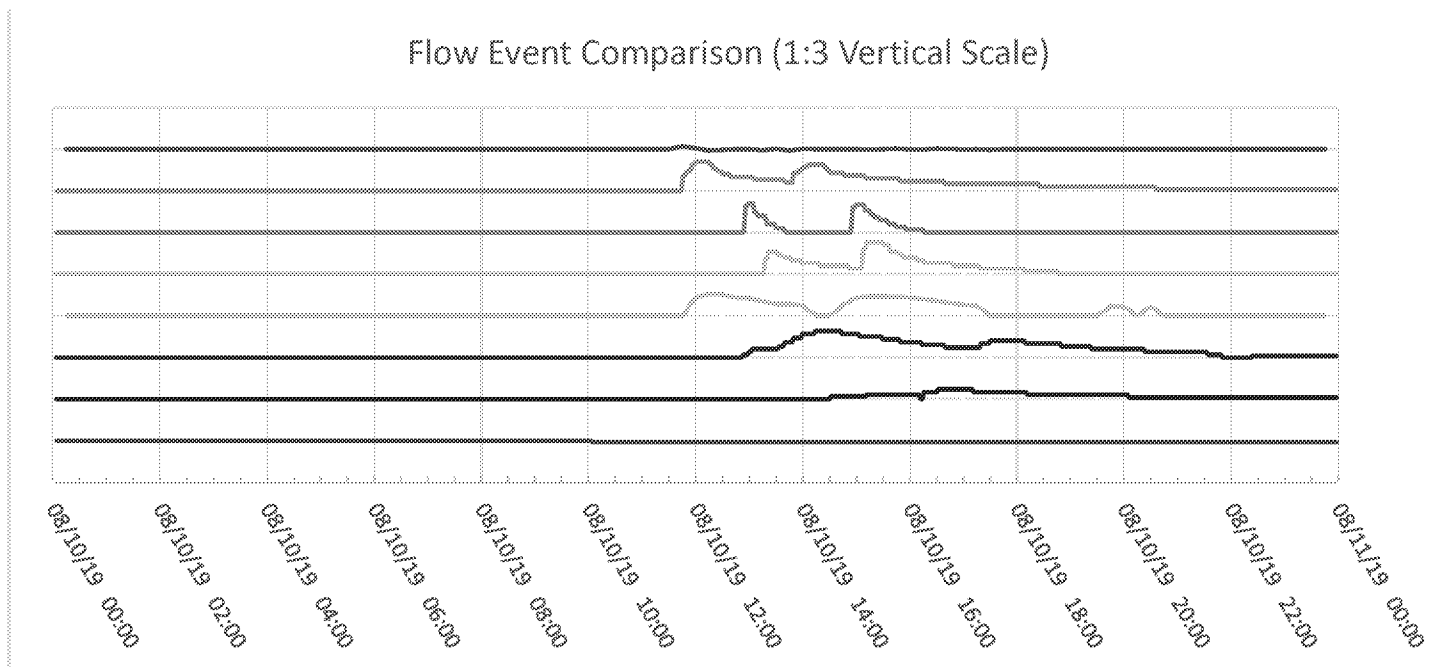
10 August 2019

Barrel Canyon Davidson Canyon Pantano Dam Pantano at Schist  
Pantano at Broadway Rillito at Dodge Rillito at La Cholla Santa Cruz at CDO

24-hour Qualitative Precipitation Estimate: Recorded at 11:55 PM 8/10/2019

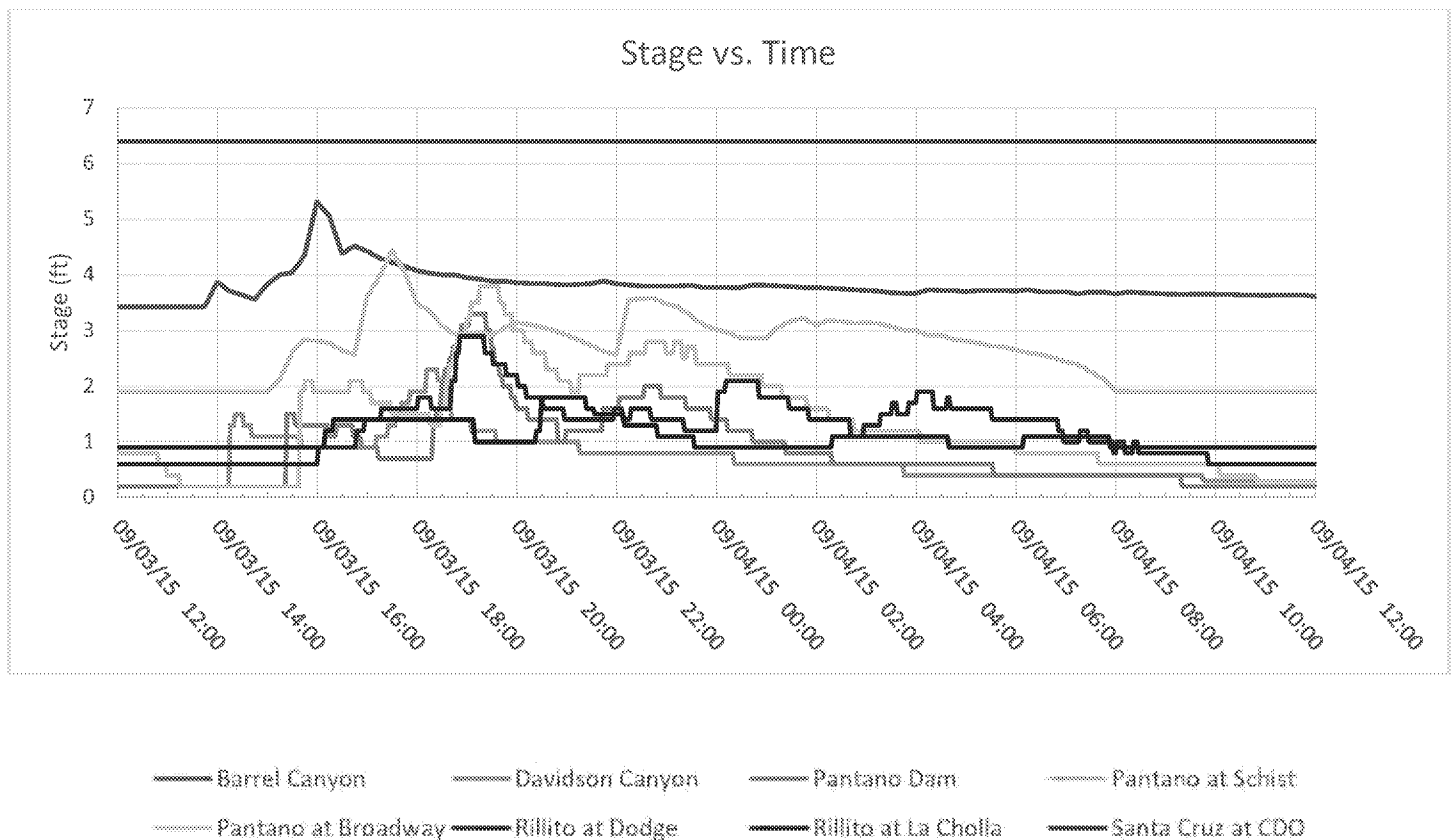
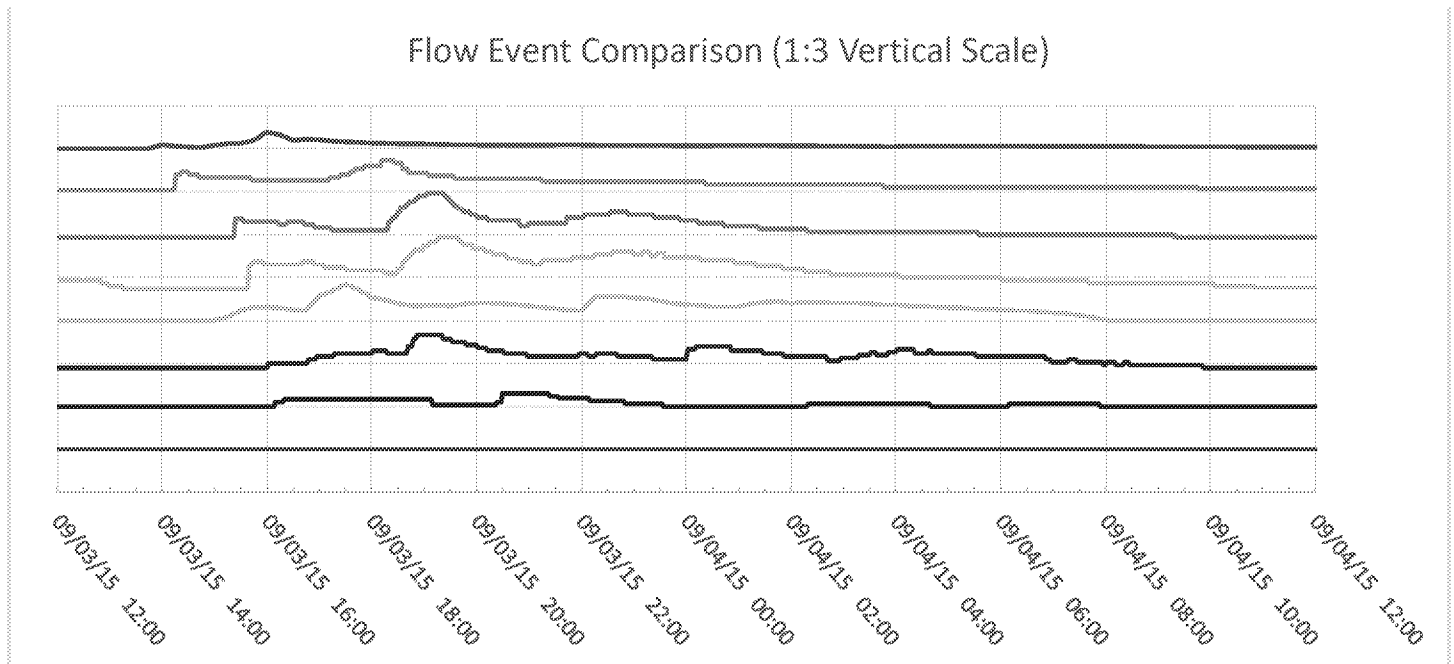
3 September 2015

24-hour Qualitative Precipitation Estimate: Recorded at 5:00 AM 9/4/2015
